Home Inspection Report

123 Main Street, White House, TN 37188

Friday July 1, 2016

16-0020

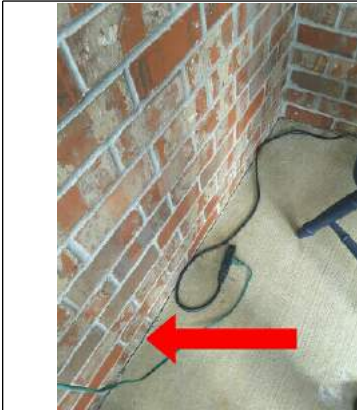
Recommend sealing gap between concrete and brick wall.

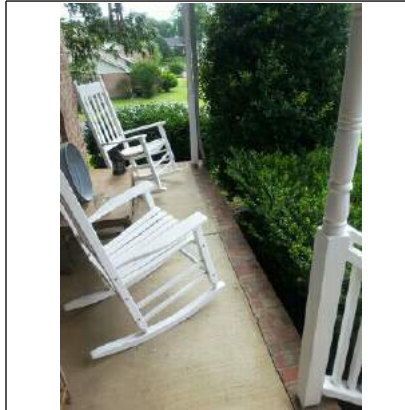
Recommend handrails on a porch over 36 inches off the ground.

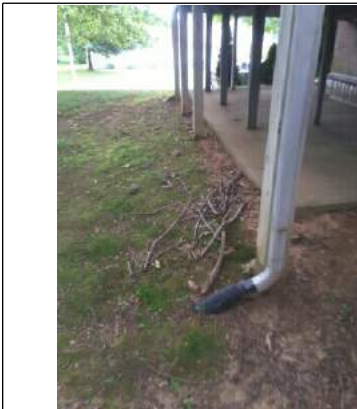
Wood to soil contact at deck support piers.

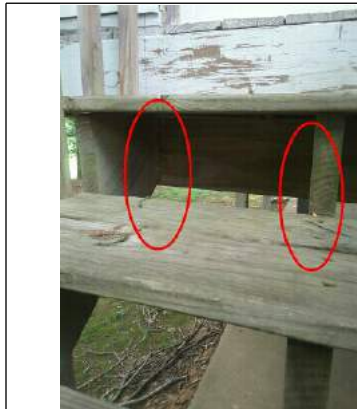
Steps not attached properly to deck. Recommend adding additional hangers.

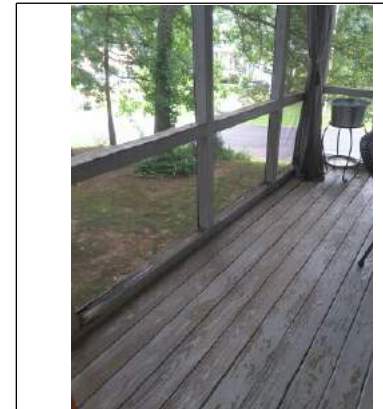
Missing balusters. Safety Hazard.

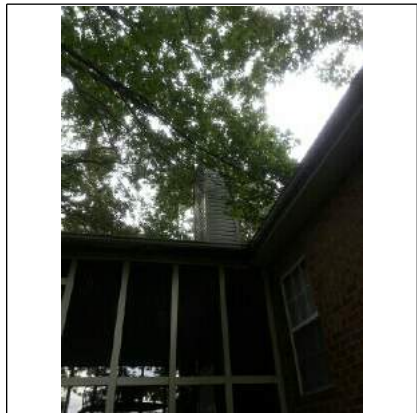
Recommend trimming trees that are in contact with the house or roof.

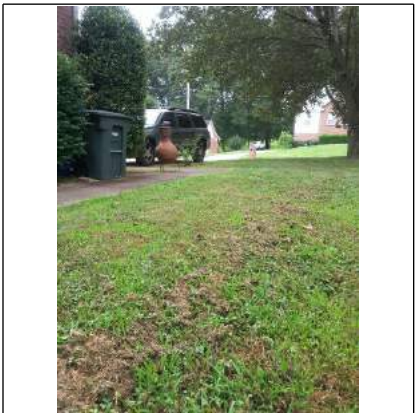
Negative grade at southwest side of house by driveway. Maybe 2%. With a heavy rainfall, it may be possible for water to enter the garage. By adding downpipe extensions, it will significantly improve water dispersion away from the house.

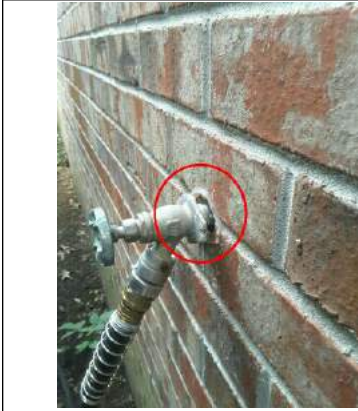
Loose hose bib on the east side, it also needs sealant in/around the hole.

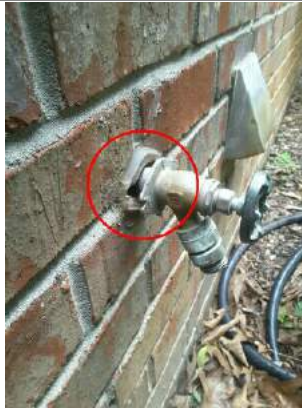
Loose hose bib on the west side of the house. Recommend sealing gaps.

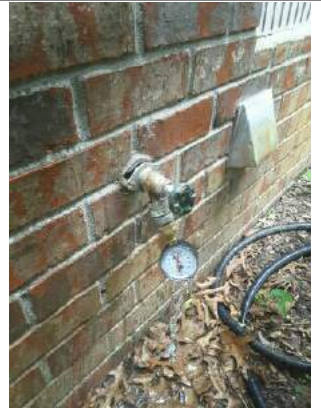
Hose bib is loose and the handle is leaking. You have 90 psi water pressure. This is on the west side.

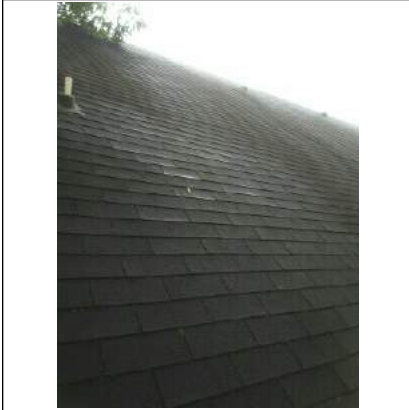
Steep shingle roof. Nearing the end of its life expectancy.

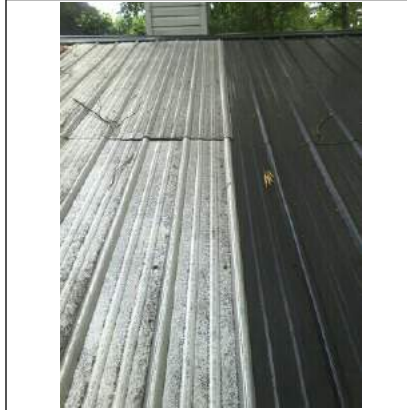
Metal roofing. This is over the deck. Some caulking has been applied to possible past trouble areas mostly around chimney.

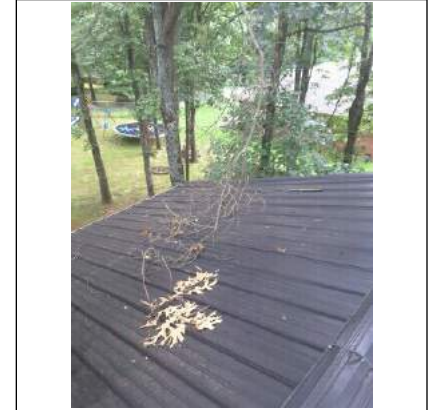
Dead limbs in contact with the roof. Recommend trimming limbs near/in contact with the house.

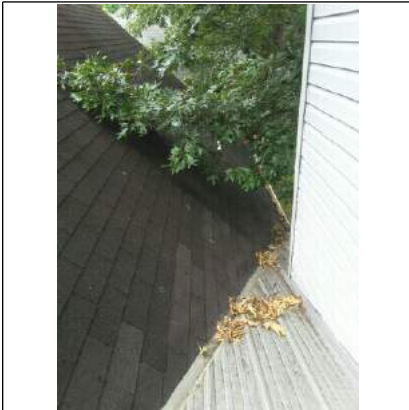
Tree limbs in contact with the roof. Dead leaves in the valley.

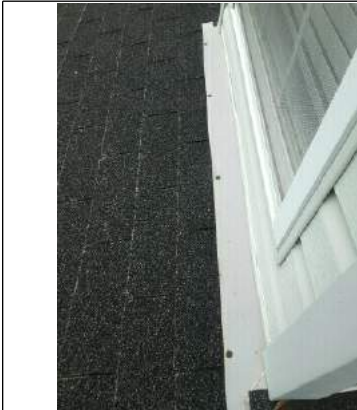
Recommend sealing exposed fasteners on skirt flashing in front of dormers at the front of the house.

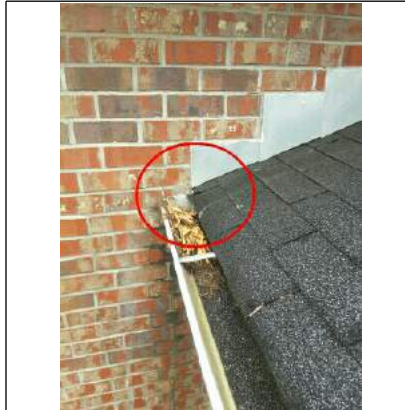
Recommend kick out flashing at gutter. Also needs to be cleaned of debris.

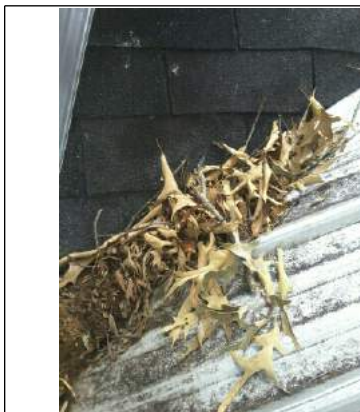
Recommend cleaning valleys and gutters of leaves and debris.

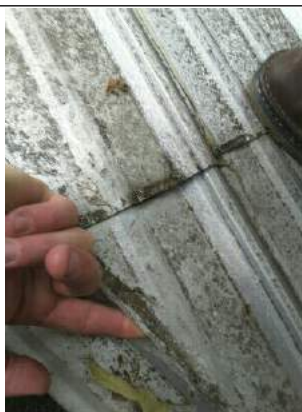
Open valley. Recommend licensed roofer evaluate/repair. I could easily slip my finger under the metal roofing next to the valley. The caulk here has failed.

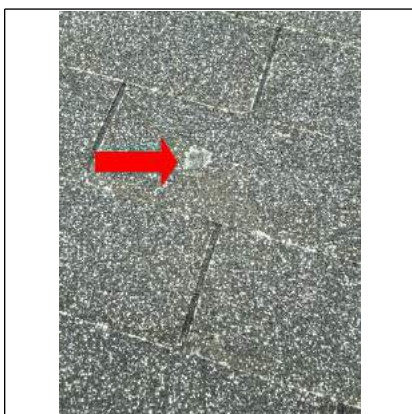
Comments Roof appeared to be nearing end of its useful life, budget to replace soon.

Notice the fiberglass showing through the shingle. There are also some hail damage spots.

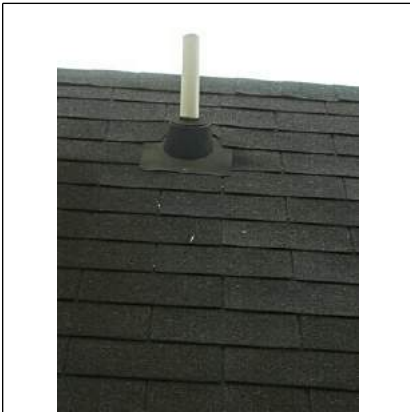
Plumbing vents seemed to be in good shape and not leaking. The exposed fasteners need to be caulked.

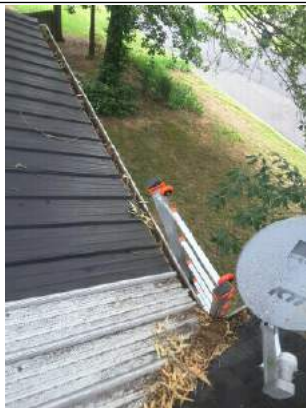
Gutter and Valley need to be cleaned.

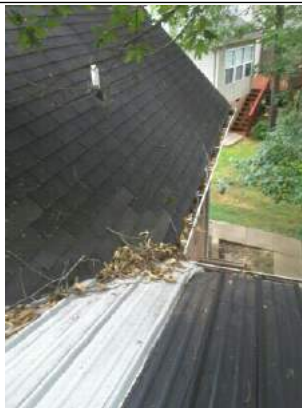
Valley and gutter on rear of house need to be cleaned.

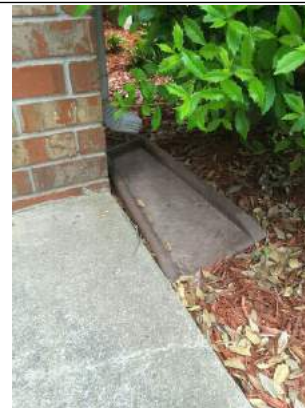
Recommend adding downpipe extensions to divert water away from foundation. 5-6 feet.

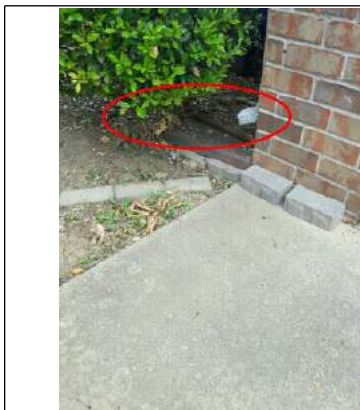
Downpipe extension needed next to garage. This will help to keep heavy rains from entering the garage.

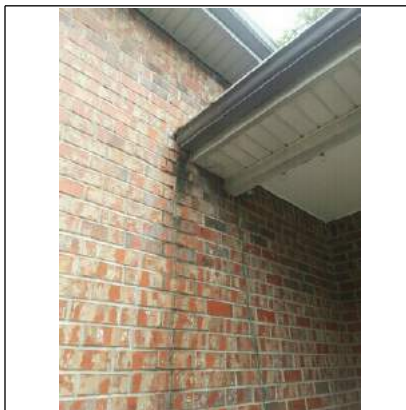
Same place where there is no kick out flashing. Water runs down the brick wall instead of in the gutter.

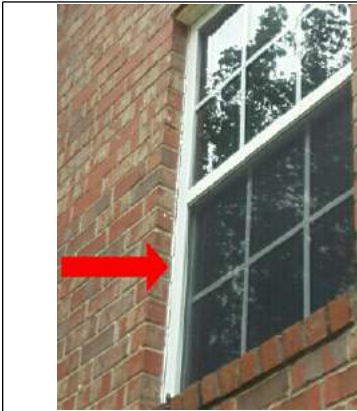
Caulking needed at windows.

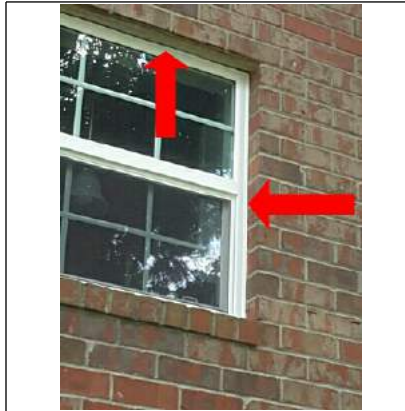
Caulking needed at windows.

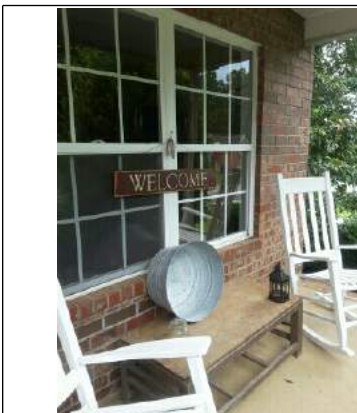
Missing window screen. Front porch.

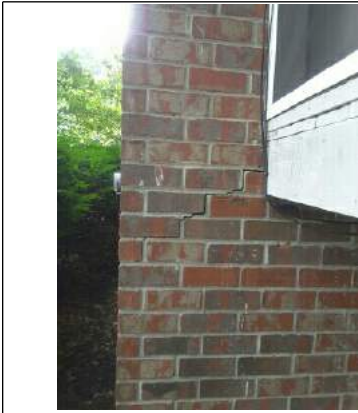
Northeast wall step cracks. This is by the deck on the corner. The block on the other side in the crawlspace had step cracks also.

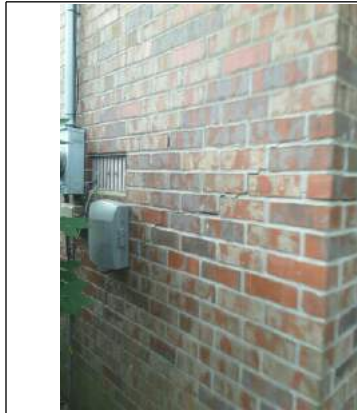
Northeast wall step cracks.

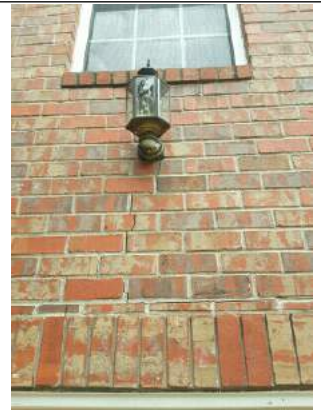
Step cracks above garage door. Recommend structural engineer evaluate.

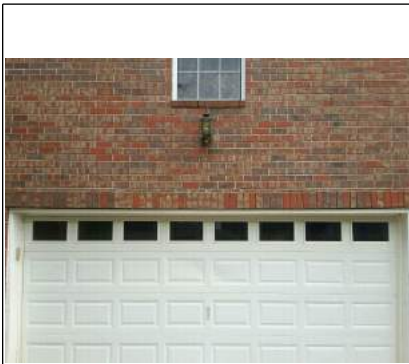
The steel lintel over the garage door is bowing slightly at the center.

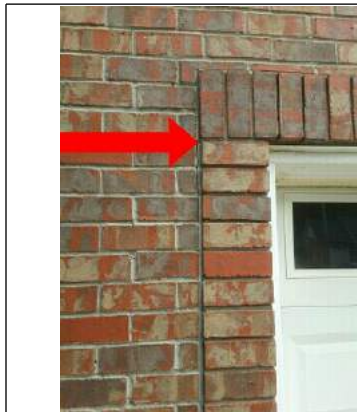
Small crack at mortar joint. Recommended repair.

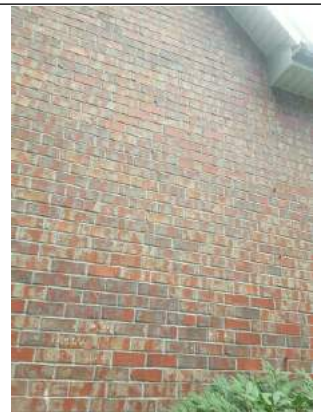
West wall step cracks. There is no bowing on this wall. I assume the cracks are from settlement due to water not being diverted away from the house properly for years.

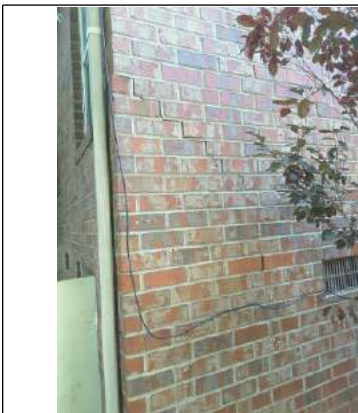
Northwest corner step cracks. The block foundation wall in the crawlspace behind this brick veneer also has a step crack. Have structural engineer evaluate.

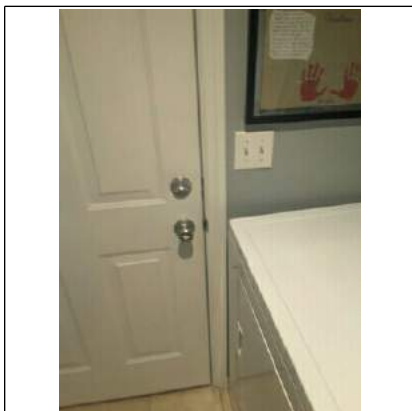
Garage entry door did not shut tight. Recommend adjusting so it will seal better.

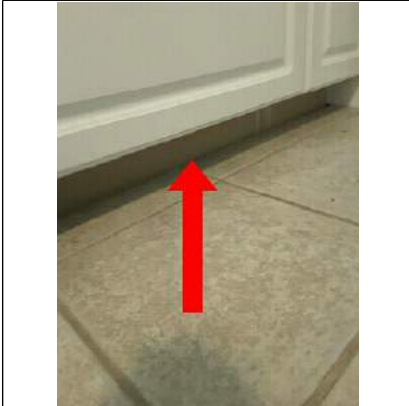
Missing base boards at kitchen cabinets. Recommend installing for sanitary reasons.

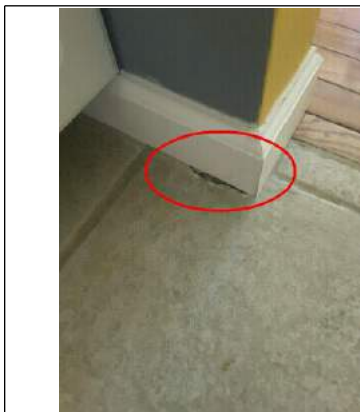
Gap between floor and wall.

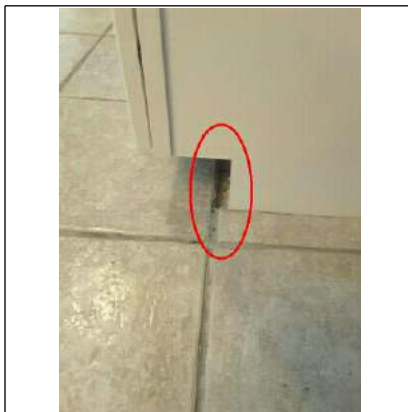
Gap between floor and cabinet base.

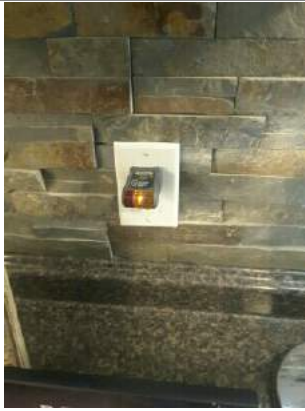
Faulty GFCI with an open ground.
Safety Hazard.

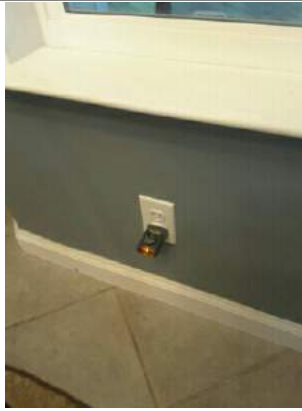
Open ground at breakfast area.
Recommend licensed electrician
repair.

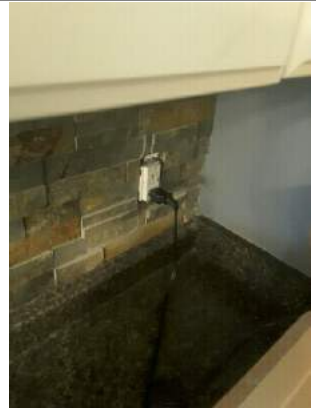
Cover plate missing. When GFCI
trips, it is a combination of resets
to properly reset each one on the
wall with the sink.

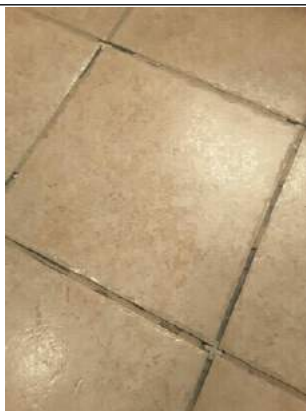
Floor was in need of some grout repairs.

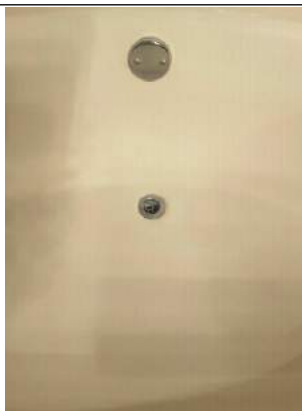
Missing drain plug in tub.

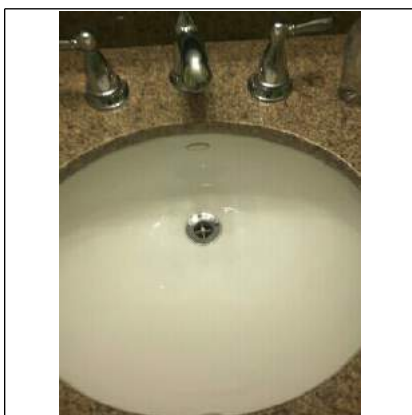
Missing drain plug in sink.

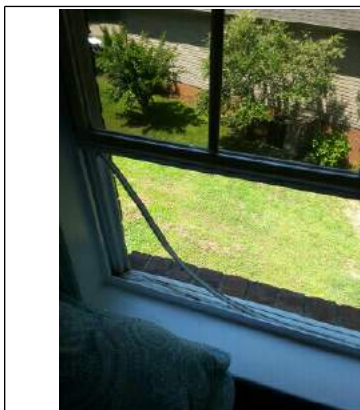
Loose weatherstripping on bedroom window.

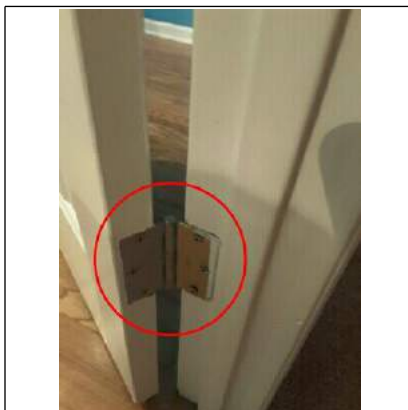
Loose hinge on bedroom door.

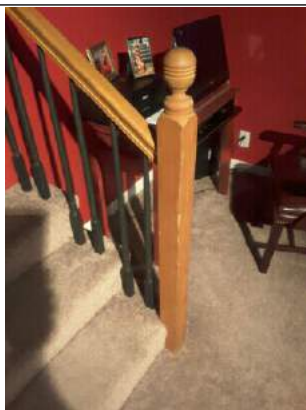
This handrail going to the bonus room is loose. Recommend repair.

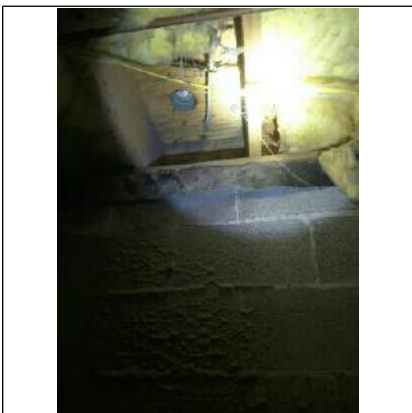
Insulation misplaced. This is the dryer discharge missing the ductwork.

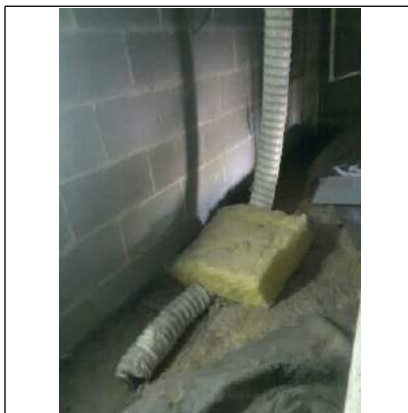
This is the duct intended for the dryer discharge disconnected. Recommend repair and discharge to the exterior.

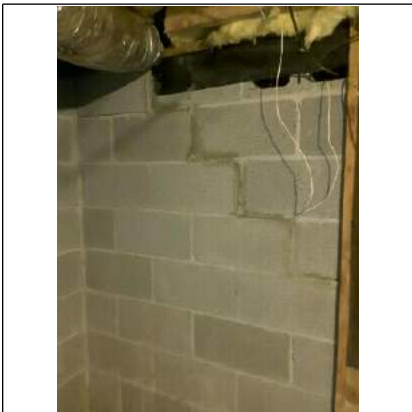
Step crack on the foundation wall at NE corner. This is next to the service panel.

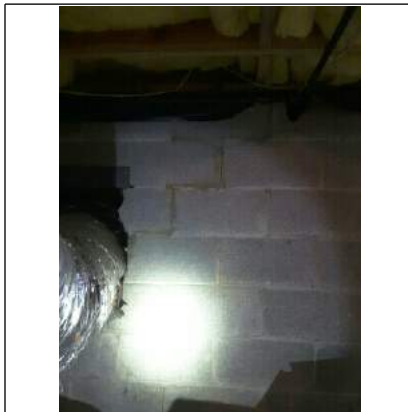
Another step crack in the foundation wall. Recommend structural engineer evaluate.

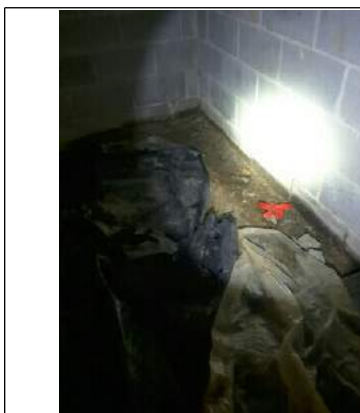
Moisture stains present. Adding downpipe extensions should help with this problem.

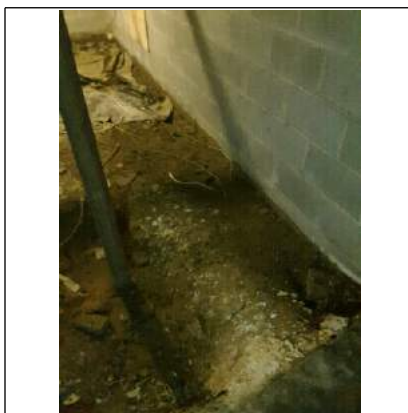
Moisture stains.

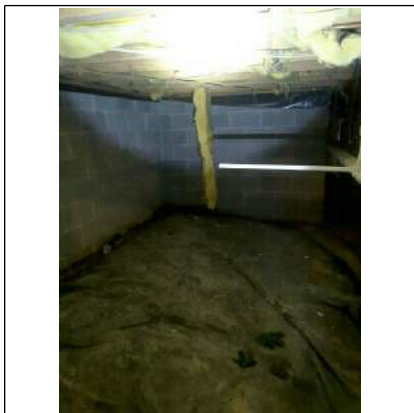
Loose and falling insulation batts. Recommend adding supports.

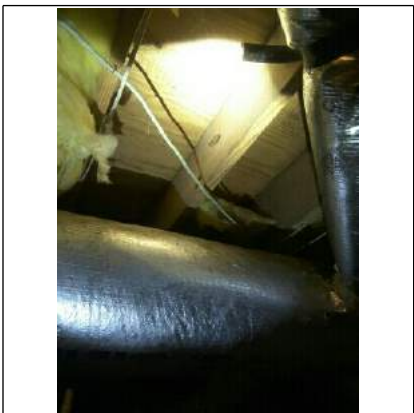
Missing floor insulation in crawlspace.

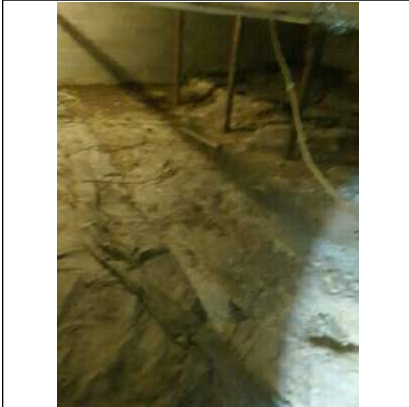
Some areas of the floor had no vapor barrier present.

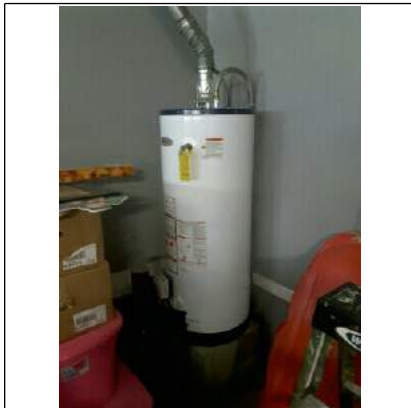
Temperature-Pressure relief valve extension should be 4"-6" off of the floor - this is a Safety Concern.

Newer water heater missing relief valve extension. Recommend licensed plumber repair.

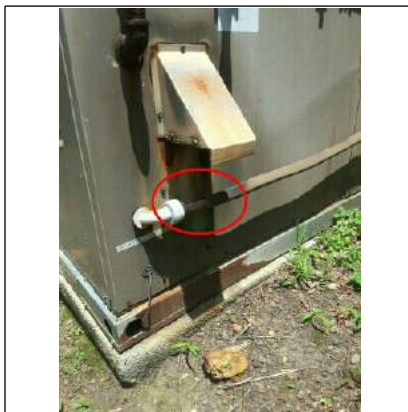
The flexible conduit directly under the exhaust flu of the HVAC unit needs repair...open.

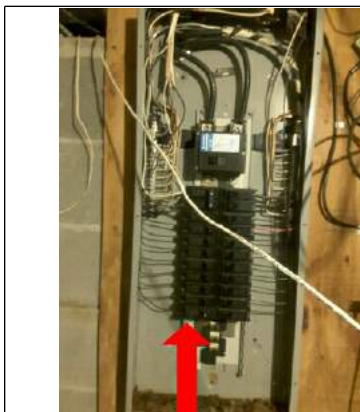
Service panel in crawlspace. The 20 amp breaker at the bottom left is oversized for the wire it is using. Should be 12 gauge, it is 14 gauge.

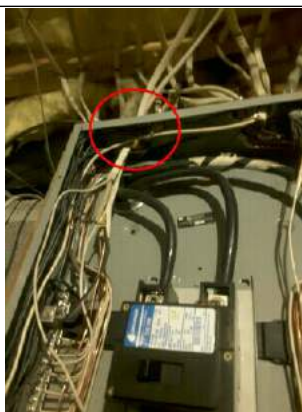
Missing protective grommet where Romex goes through electric panel. Recommend licensed electrician repair.

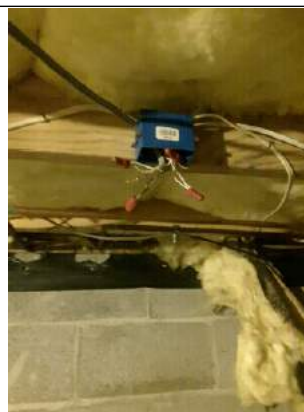
Open junction box in crawlspace. Recommend licensed electrician repair.

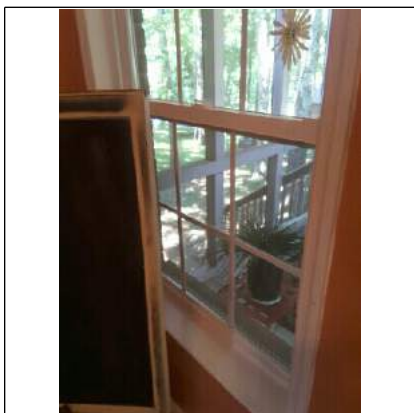
Comments The window would not open at all.

Window was stuck shut.
